TECHNICAL REPORT ARLCB-TR-80023

LASER TREATMENT OF CHROMIUM PLATED STEEL

R, S. Montgomery

June 1980

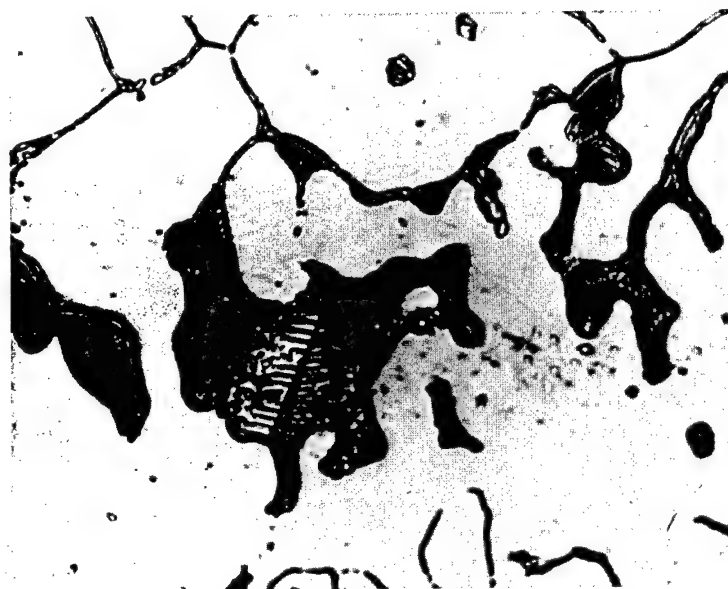
Fig. 6. Islands of another phase in intermediate layer (magnification 800X).

[6] suggests that the compound would not form during the rapid quench associated with laser treatment. In any case the intermediate layer showed no tendency to crack at hardness impression loads which caused severe cracking of the chrome plate. Therefore it was not excessively brittle. There were also islands of another phase which appeared to be chromium carbide in the intermediate layer (see Fig. 6). Scanning Auger spectroscopy indicated that there was an appreciable amount of carbon present as carbide in the intermediate layer especially at the interface between the chromium and the intermediate layer so it seems likely that this identification is indeed correct.

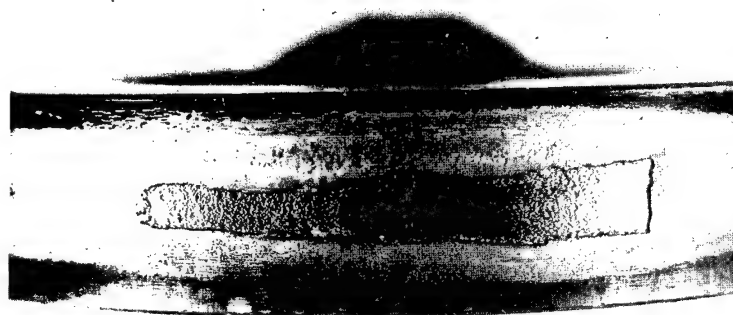
Fig. 14. Surface of a laser-treated roller after testing showing peeling of chrome plate.

The laser-treated rollers ran only from 14 to 47 s before large sections of the chrome plate peeled away (see Fig. 14). The nine rollers treated at 40 in min^{-1} ran from 14 to 47 s with an average life of only 25 s. Four of the rollers treated at 20 in min^{-1} could be tested; they ran from 15 to 25 s with an
